The complex atmospheric corrosion of α/δ bronze bells in a marine environment

A. Petitmangin, I. Guillot, A. Chabas, S. Nowak, M. Saheb, S.C. Alfaro, C. Blanc, C. Fourdrin, P. Ausset

α/δ bronze bells are heritage materials subject to corrosion. The alteration of a high-tin bronze bell casted in the 1930s and exposed to a marine environment in a steeple was studied. The ternary bronze (Cu-Sn-Pb) alloy displays inclusions and a porosity due to micro-shrinkages and poor gas evacuation. This altered bronze is characterized to (1) assess the influence of the manufacturing techniques and (2) hypothesize a micro-infiltration scenario of its alteration.

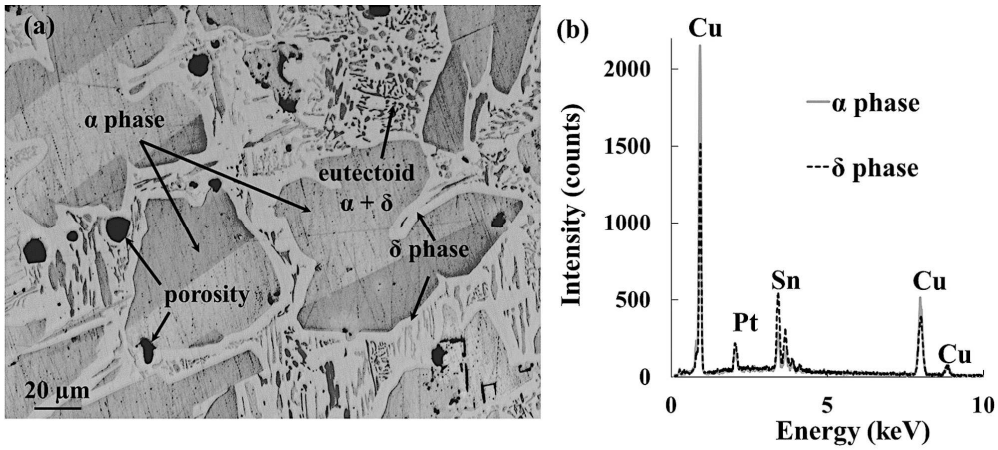
Optical microscopic observations (Fig.1a) confirm the two-phase microstructure of the alloy: a dendritic α single phase with an eutectoid α/δ interspersed between the dendritic arms. δ has a higher tin content (Sn 31.84%wt) than α (Sn 14.94%wt) (Fig. 1b), in agreement with the Cu-Sn phase diagram [19].

Fig. 1: (a) Optical micrography of the microstructure of the internal part of the bell. In the α/δ eutectoid, the δ phase appears in lighter shade of gray and α in gray. (b) EDS analyses of α and δ phases.

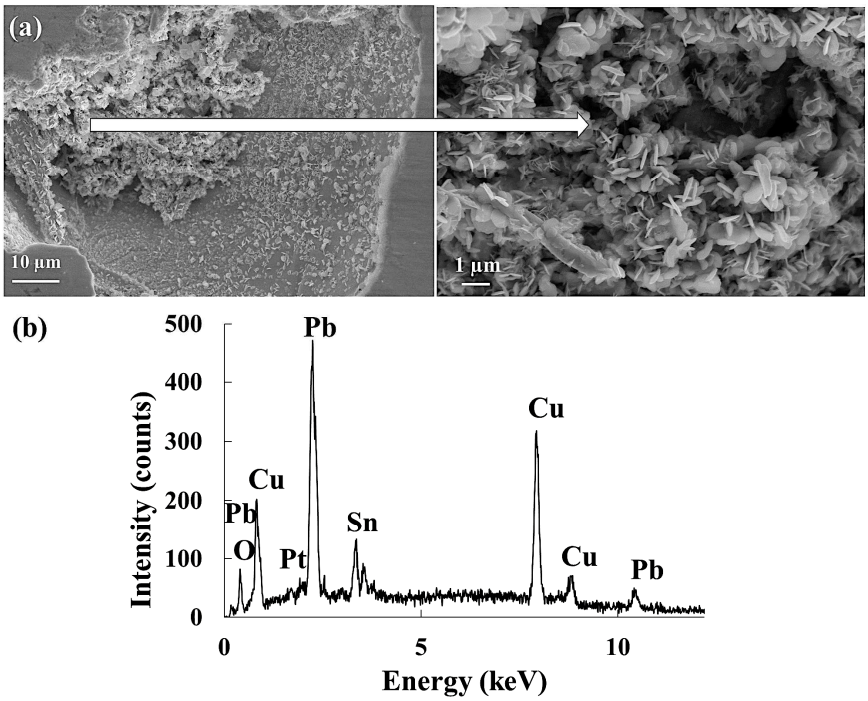
Microscopic observations reveal in interdendritic spaces some porosities, which are due to micro-shrinkages or to a large content of gas in the liquid metal during the casting. Some of the cavities could possibly be ascribed to lead globules being removed during the sample preparation. SEM-EDS observations reveal some residual crystals, corresponding to lead and lead oxides (Fig. 2). Because of the insolubility of lead in the bronze matrix [22], the alloy can be considered as a ternary bronze Cu-Sn-Pb (Pb 1.22%wt-Table 3).

Fig.2: (a) SEM-BSE image and (b) SEM-EDS analyses of alloy porosities.

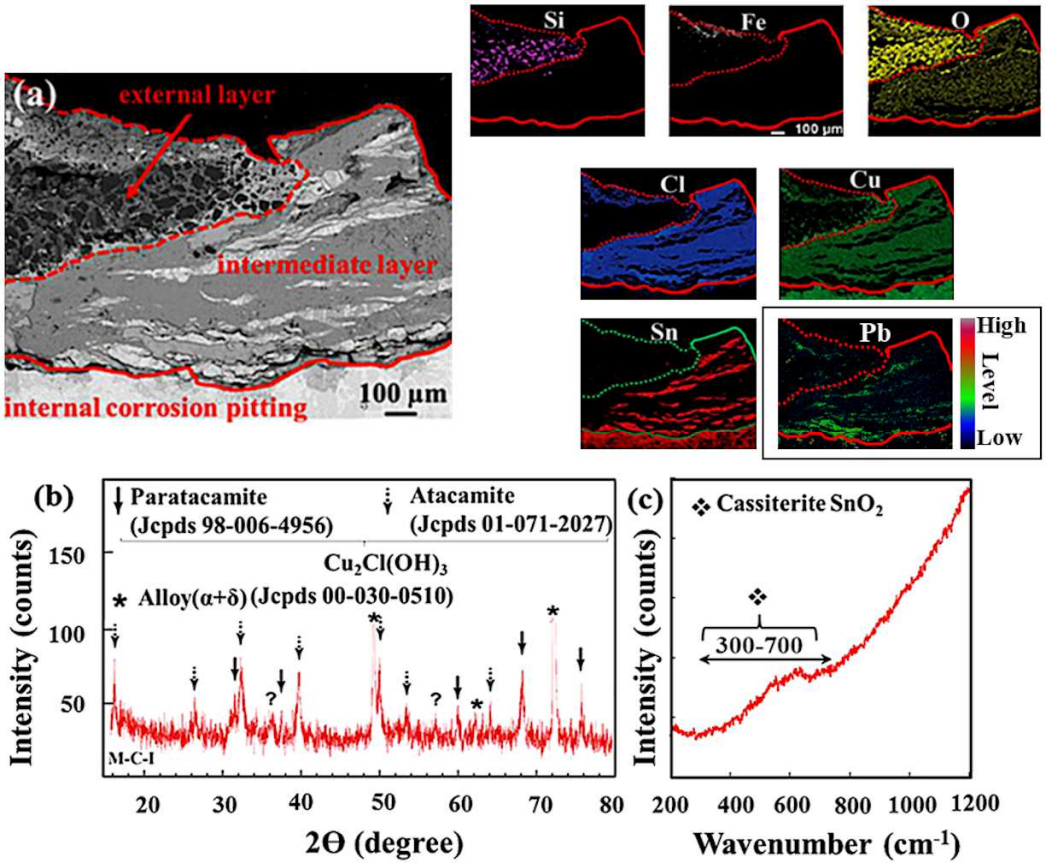
To understand better the corrosion, SEM-EDS and micro XRD analyses were performed on cross sections of the internal face of the bell (Fig.3). The choice of a specific sampling zone (crown or profile) did not affect the structure and composition of the corrosion. The SEM observations highlighted three distinct alteration areas: **(i)** A porous **external layer** presenting phases or elements characteristic of the bell mold. This layer corresponds to the transformed medium. **(ii)** A more or less continuous, **intermediate layer**. **(iii) Internal corrosion pitting** which mainly affects the α phase.

The external layer (Fig.3) is in localized zones, highly enriched in oxygen associated with silicon and iron and as compared to the intermediate layer, often depleted in copper and tin. The exogenous compounds are characteristic of an enrichment in clay, typical of the manufacturing techniques. Traces of lead are also observed and terrigenous or anthropogenic deposits can be associated with the exogenous compounds.

Fig. 3: The internal face of the bell crown: (a) SEM-EDS elements map with the level map of lead (b) Micro XRD analyses of the cross section (c) Raman analyses of the tin oxide.

On the internal part of the crown (Fig.3 (a)), a homogeneous EDS signal of oxygen in the intermediate layer is observed. The layer presents, thick zones enriched in both copper and chlorine alternating with, occasionally, as observed on Fig.3 (a), tin-enriched and copper depleted zones where lead is also present. The micro XRD patterns (Fig.3 (b)) of the same zones display mostly copper hydroxi-chloride compounds under atacamite and paratacamite ($Cu_2Cl(OH)_3$) and a lack of tin species. This lack could be imputed to the amorphous nature of tin oxide [4] or to the thickness of the areas, with large copper areas masking the XRD signal of the thinner tin zones. However, the broad band between 300 cm^{-1} and 700 cm^{-1} on the Raman analyses (Fig.3 (c)) is in support of the presence of nanometric crystallites of cassiterite SnO_2 [4,23]. No lead compounds were detected by Raman analyses certainly because of the low amount of this element in the tin corrosion products.

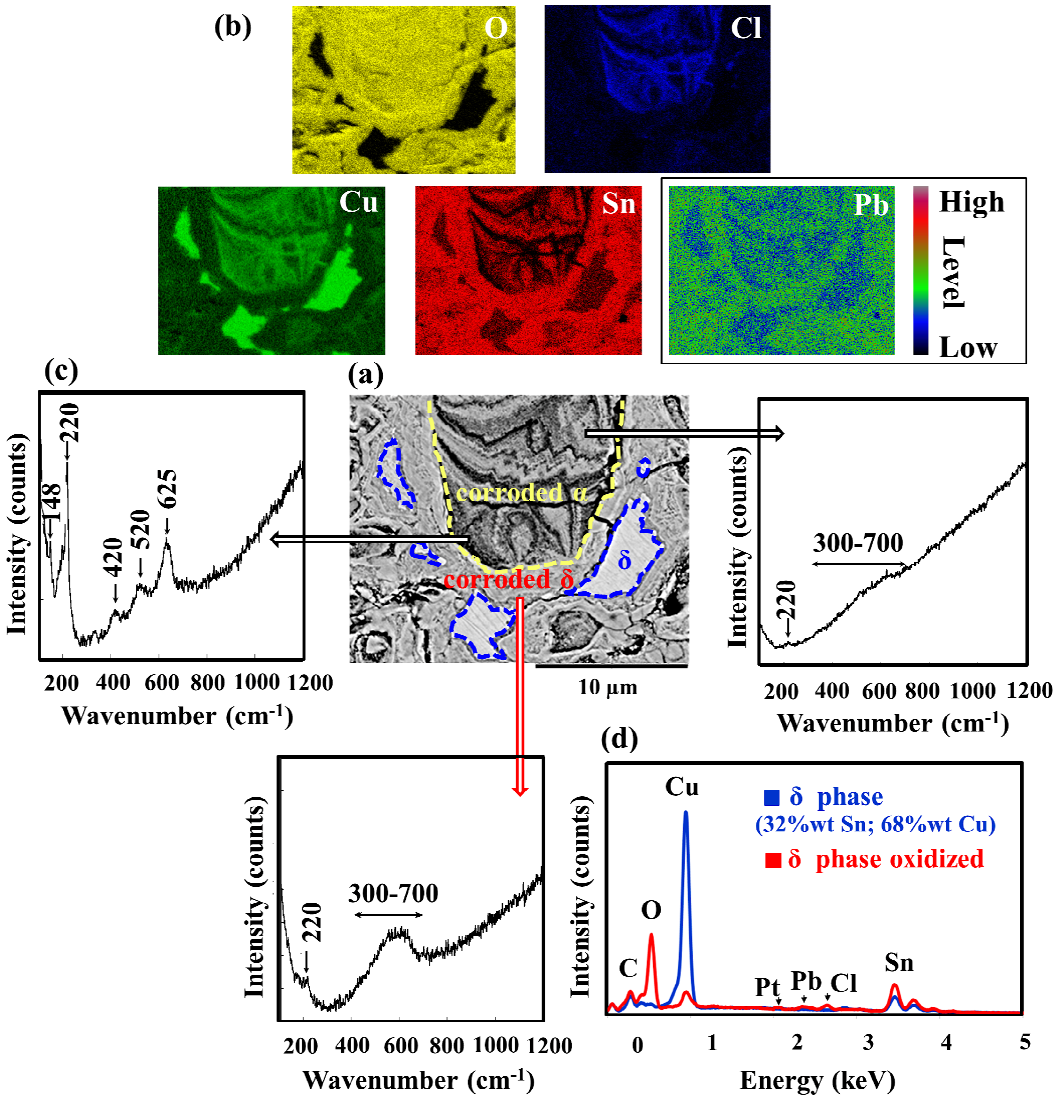
On the internal face of the crown (Fig.4) the oxygen EDS signal is sharp and uniformly distributed, characteristic of a strong corrosion. Oxygen is associated with chlorine and copper, with some areas of exception where these two elements are replaced by tin. The corrosion of α has a multilayer microstructure. Lead is also present in α dendrite corrosion. Its EDS signal is not located as lead corroded globules (Fig 3), but is associated with the tin signal, more characteristic of a diffusing behaviour in tin corrosion products. The Raman spectrum of the copper oxychloride layers (Fig 4 (c)) contains Cu_2O vibrations bands (148 and 220 cm^{-1} and a vibrational triplet at 420, 520 and 625 cm^{-1}). The thin layers, rich in tin compounds, show a weak band between 300 and 700 cm^{-1} more in agreement with the presence of SnO_2 [23], but Cu_2O traces are confirmed by the weak band near 220 cm^{-1}. No signal for copper chloride is present because of an amorphous behavior and no lead compounds, due to certainly their small quantity.

Fig. 4: On the SEM image (a), the corroded α phase is surrounded by yellow dotted lines and the δ phase by blue dots. Oxidized δ is in gray between them. (b) SEM-EDS map of Cu, Sn, O, Cl with the level map of Pb (c) Raman spectra of the corroded α phase and δ phase. (d) EDS analyses of the δ phase and the corroded δ phase.

The eutectoid corrosion relates not only to the α phase but also to the δ one. On Fig.4, according to semi quantitative SEM-EDS analyses, the uncorroded δ phase is associated to the altered δ phase. No signal related to copper and chlorine, but a high concentration of tin with oxygen and little EDS signal of copper are detected in the corroded δ phase. This is due to an important copper depletion. The large band between 300 cm^{-1} and 700 cm^{-1} on the Raman analyses corresponds to a predominance of SnO_2 [23] and the very weak band at 220 cm^{-1} to Cu_2O, present in small quantity. Small amount of lead is also associated with tin EDS signal in altered δ phase.

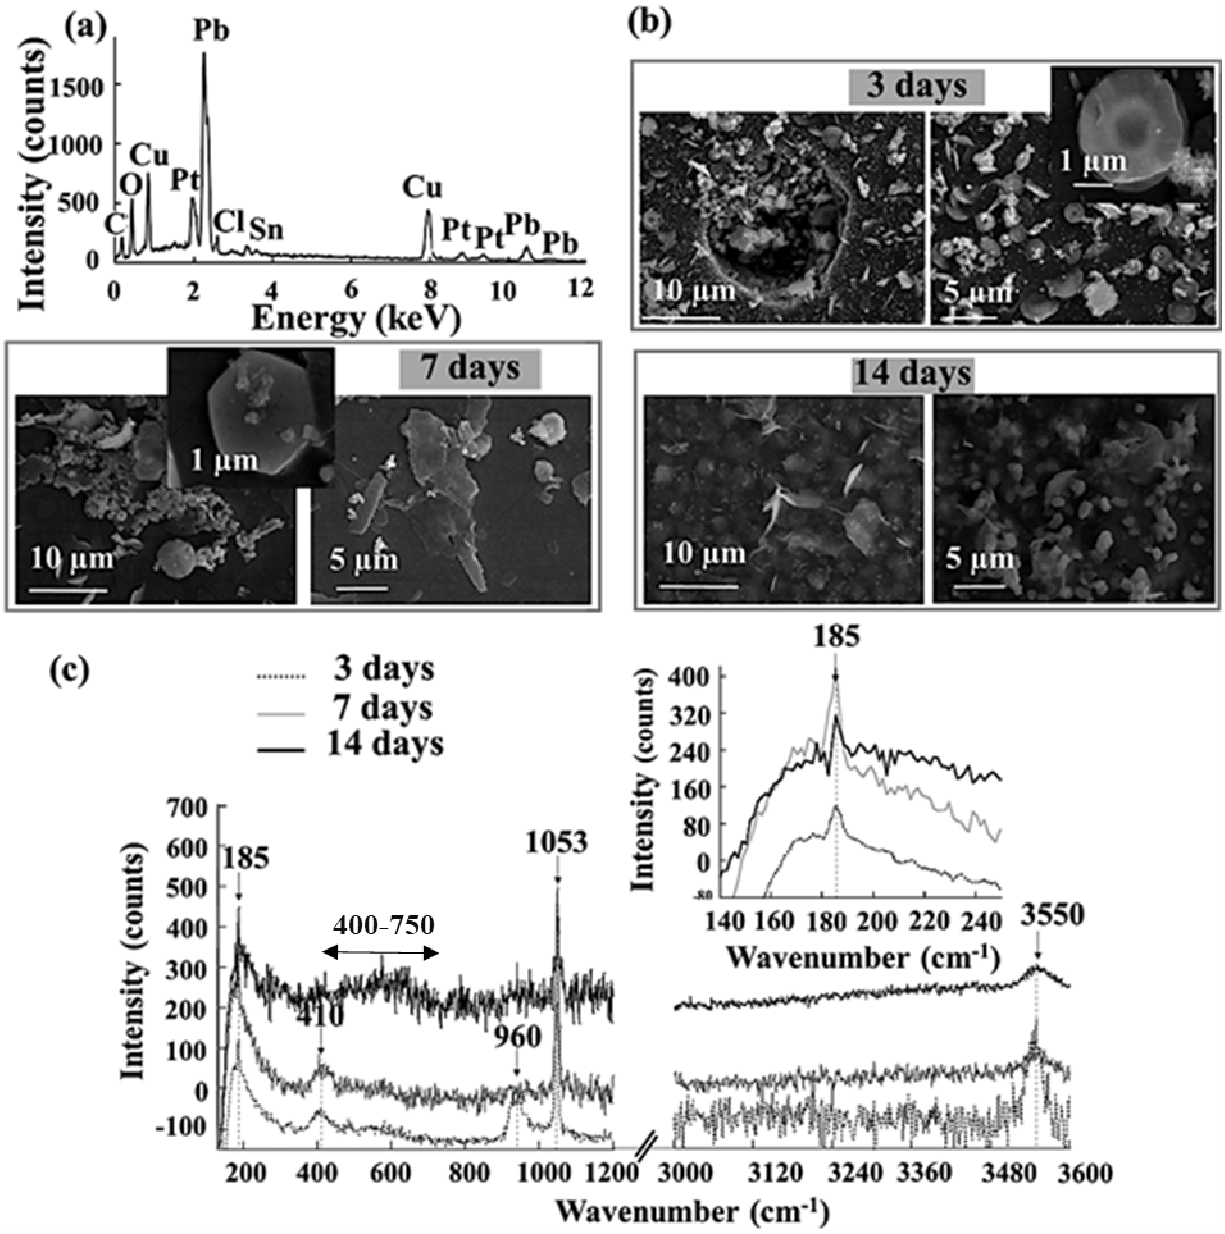
Visual investigation of the alloy specimens reveals the progressive formation of a whitish grey area. The more or less porous surface of the alloy displays an irregular layer of corrosion products particularly rich in lead, oxygen and carbon, with chlorine traces (Fig. 5a). SEM observations (Fig. 5b) show hexagonal crystals in platelets. After 7 days, some prismatic crystals with an engraving of their edges are observed. Over these two forms of crystallites, the growth of small square-based crystals is observed.

The Raman analyses (Fig. 5c) show that the lead compounds are essentially carbonates. Indeed, the vibration band at 3550 cm^{-1} and that at 410 cm^{-1} , which is observed after 3 days and gradually disappears for longer exposures, correspond to hydrocerussite ($Pb_3(CO_3)_2(OH)_2$) [24]. This lead carbonate grows to hexagonal form [25, 26] as shown on the SEM images. The vibration band at 1053 cm^{-1} can be due to either hydrocerussite or cerussite (Pb_3CO_3) whose presence is confirmed by the observation of prismatic crystals (Fig. 5b) [24,27]. Lead sulfate is also present after 3 days of alteration, as indicated by the band near 960 cm^{-1}[28]. Moreover, the traces of chlorine on the EDS signal associated to the width of the band at 1053 cm^{-1}, particularly large after 14 days, reflect the presence of lead chloride in small quantity. Independently of the corrosion duration, there is always a small band at 185 cm^{-1} indicative of the presence of phosgenite ($Pb_2Cl_2CO_3$) [24]. These lead chlorides could correspond to the small square-based crystals observed on the SEM images. However, the presence of lead oxides cannot be excluded because of the square form of these crystallites [27,29]. After 14 days of alteration a large band is also observed, between 400 and 750 nm, corresponding to traces of copper oxide and a predominance of tin oxide [23].

Fig.5: (a) EDS analysis and (b) SEM-BSE images for 3, 7 and 14 days of corrosion in marine solution. (c) Raman analysis of corrosion products.

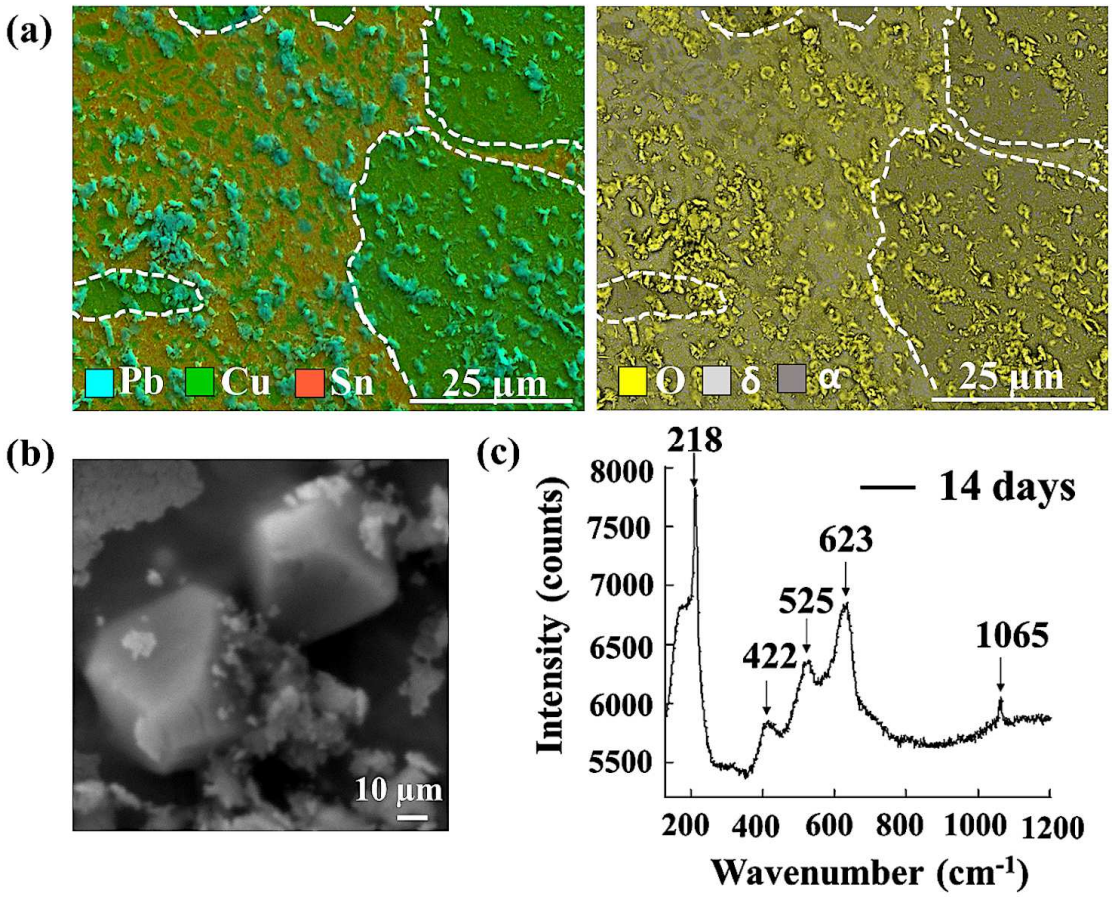
The alloy microstructure (Fig 6) shows that, the lead corrosion pitting mainly develops on the dendritic and eutectoid α phase, whereas the δ phase which has a higher tin content presents less located lead and oxygen EDS signal. Whatever the duration of alteration, the same observations were made. However, after 14 days, some α dendrites display small octahedral crystals of cuprite as evidenced by the 218 cm^{-1} vibration band and the vibrational triplet (422 cm^{-1}; 525 cm^{-1}; 623 cm^{-1}) on the Raman spectra [23]. Trace of nantokite (CuCl) cannot be excluded as indicated by the thin band at 1065 cm^{-1} [30]. The role of Pb on the corrosion of Cu-rich dendrites and α/δ eutectoid will be discussed (§5).

Fig.6: (a) SEM image of the alloy microstructure with Pb,Cu,Sn,O EDS signals for 3 days alteration. Dendritic α phase is surrounded by white dotted lines (b) SEM-BSE image of the Cu_2O octahedra and (c) their Raman spectrum (14 days of alteration).

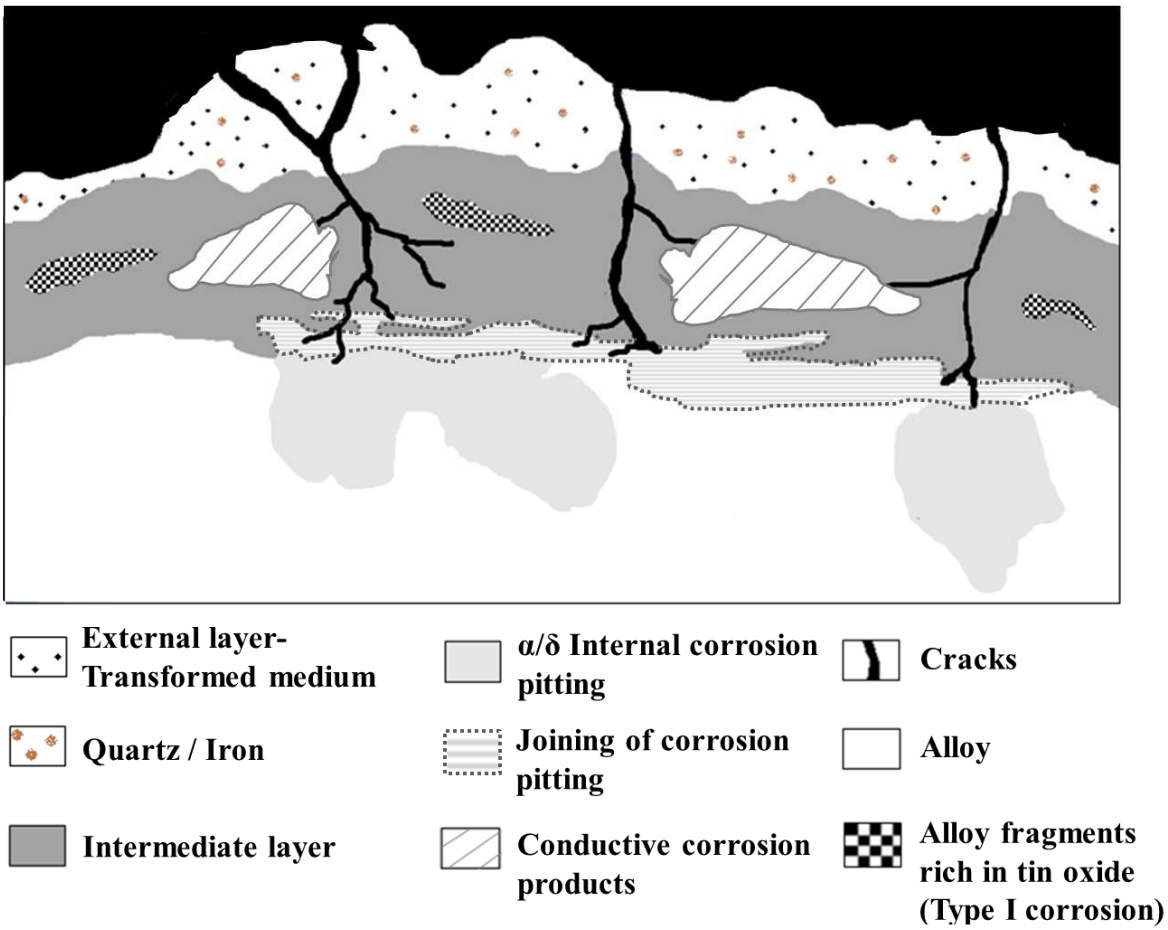
Fig. 7: Schematic representation of corrosion layers on the bronze bell: the development of internal corrosion pitting is favored by the micro-cracks inside the brittle patina and the interconnection of these pitting and the development of conductive corrosion products.

The more cracked the alteration layer is, the more permeable the patina becomes to the environment species (Fig.7). Thus, corrosion pits gradually tend to join together and the repetition of these reunions eventually favors the development of the intermediate layer.

If the conducting corrosion products (Fig.7) are present in the patina and are connected to the alloy, they transport electrons and provoke the decoupling of the anodic (bronze

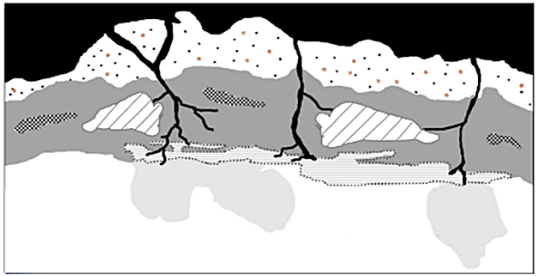
Micro-infiltrating corrosion

α/δ Internal corrosion pitting

Joining of corrosion pitting

Conductive corrosion products

Cracks

Alloy fragments rich in tin oxide (Type I corrosion)
